3D Interior Measurement

THE ACOUSTIC CAMERA AS SOLUTION FOR A FULL-VEHICLE NVH ANALYSIS IN AN AIRCRAFT

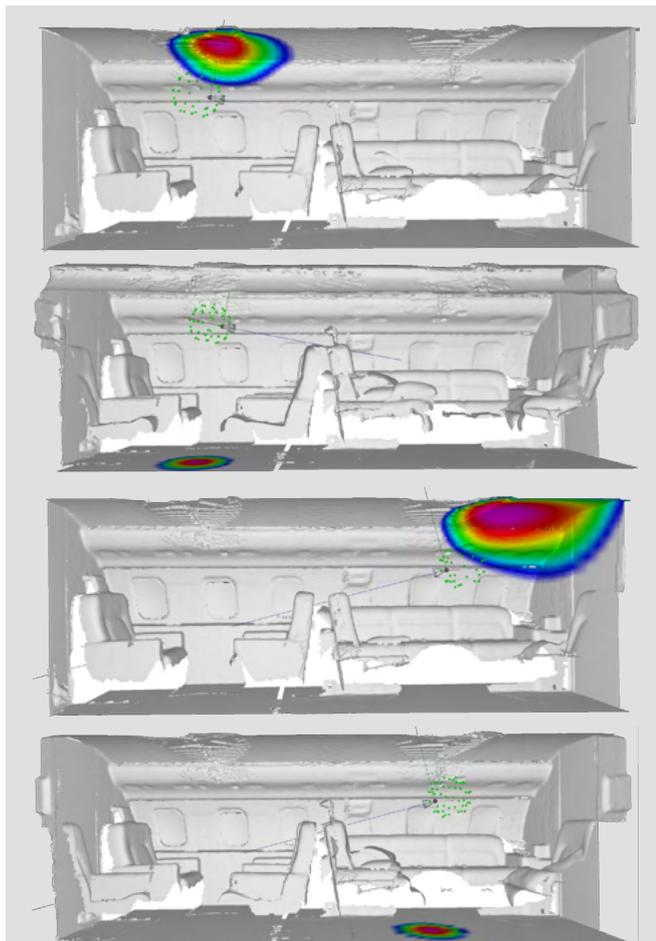
Fig. 2 Time domain results for the front and the back measurement positions

Time Domain: Fig. 2 visualizes the results from two different array positions. The loudest sound sources were located at the ceiling above the chosen measurement position, 85.22 dB (front) and 83.06 (back) dB. In both scenarios, ground-reflected sources, around 68 dB, can also be seen.

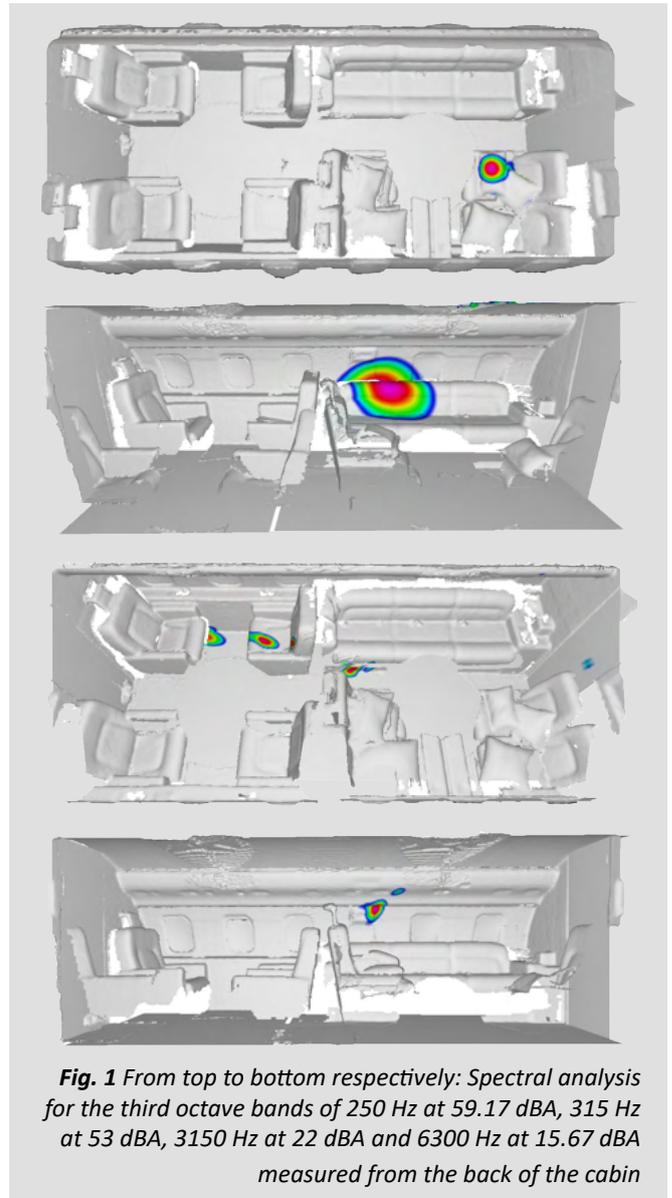
Fig. 1 From top to bottom respectively: Spectral analysis for the third octave bands of 250 Hz at 59.17 dBA, 315 Hz at 53 dBA, 3150 Hz at 22 dBA and 6300 Hz at 15.67 dBA measured from the back of the cabin

Frequency Domain: The origin of the noise was found in three different third octave bands of 250 Hz, 315 Hz, 3150 Hz and 6300 Hz. The sound was radiating from the floor in the middle of the cabin and from the side of the fuselage (see Fig. 1).
